Maine Forestry Best Management Practices Use and Effectiveness Executive Summary 2008

Forest Policy and Management Division

August 2009

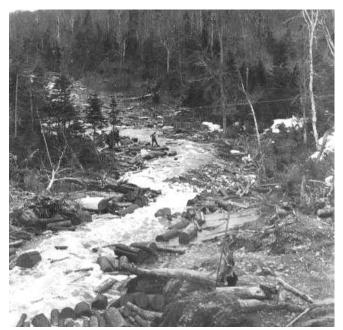
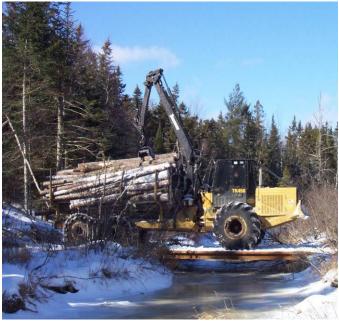
Then and now. As recently as the 1970's little consideration was given to protecting water quality on timber harvests as the highly eroded banks in the log drive photo on the left illustrates. In contrast, today there is a general acceptance of BMPs by the forestry and logging professions. Sights like forwarders being used to minimize ground disturbance and temporary bridges to protect the integrity of stream channels indicate how far BMPs have come.
